Debris/Ice/TPS Assessment And Photographic Analysis For Shuttle Mission STS-31R

Charles G. Stevenson
NASA/Kennedy Space Center

DEBRIS/ICE/TPS ASSESSMENT
AND
PHOTOGRAPHIC ANALYSIS
OF
SHUTTLE MISSION STS-31R

April 24, 1990

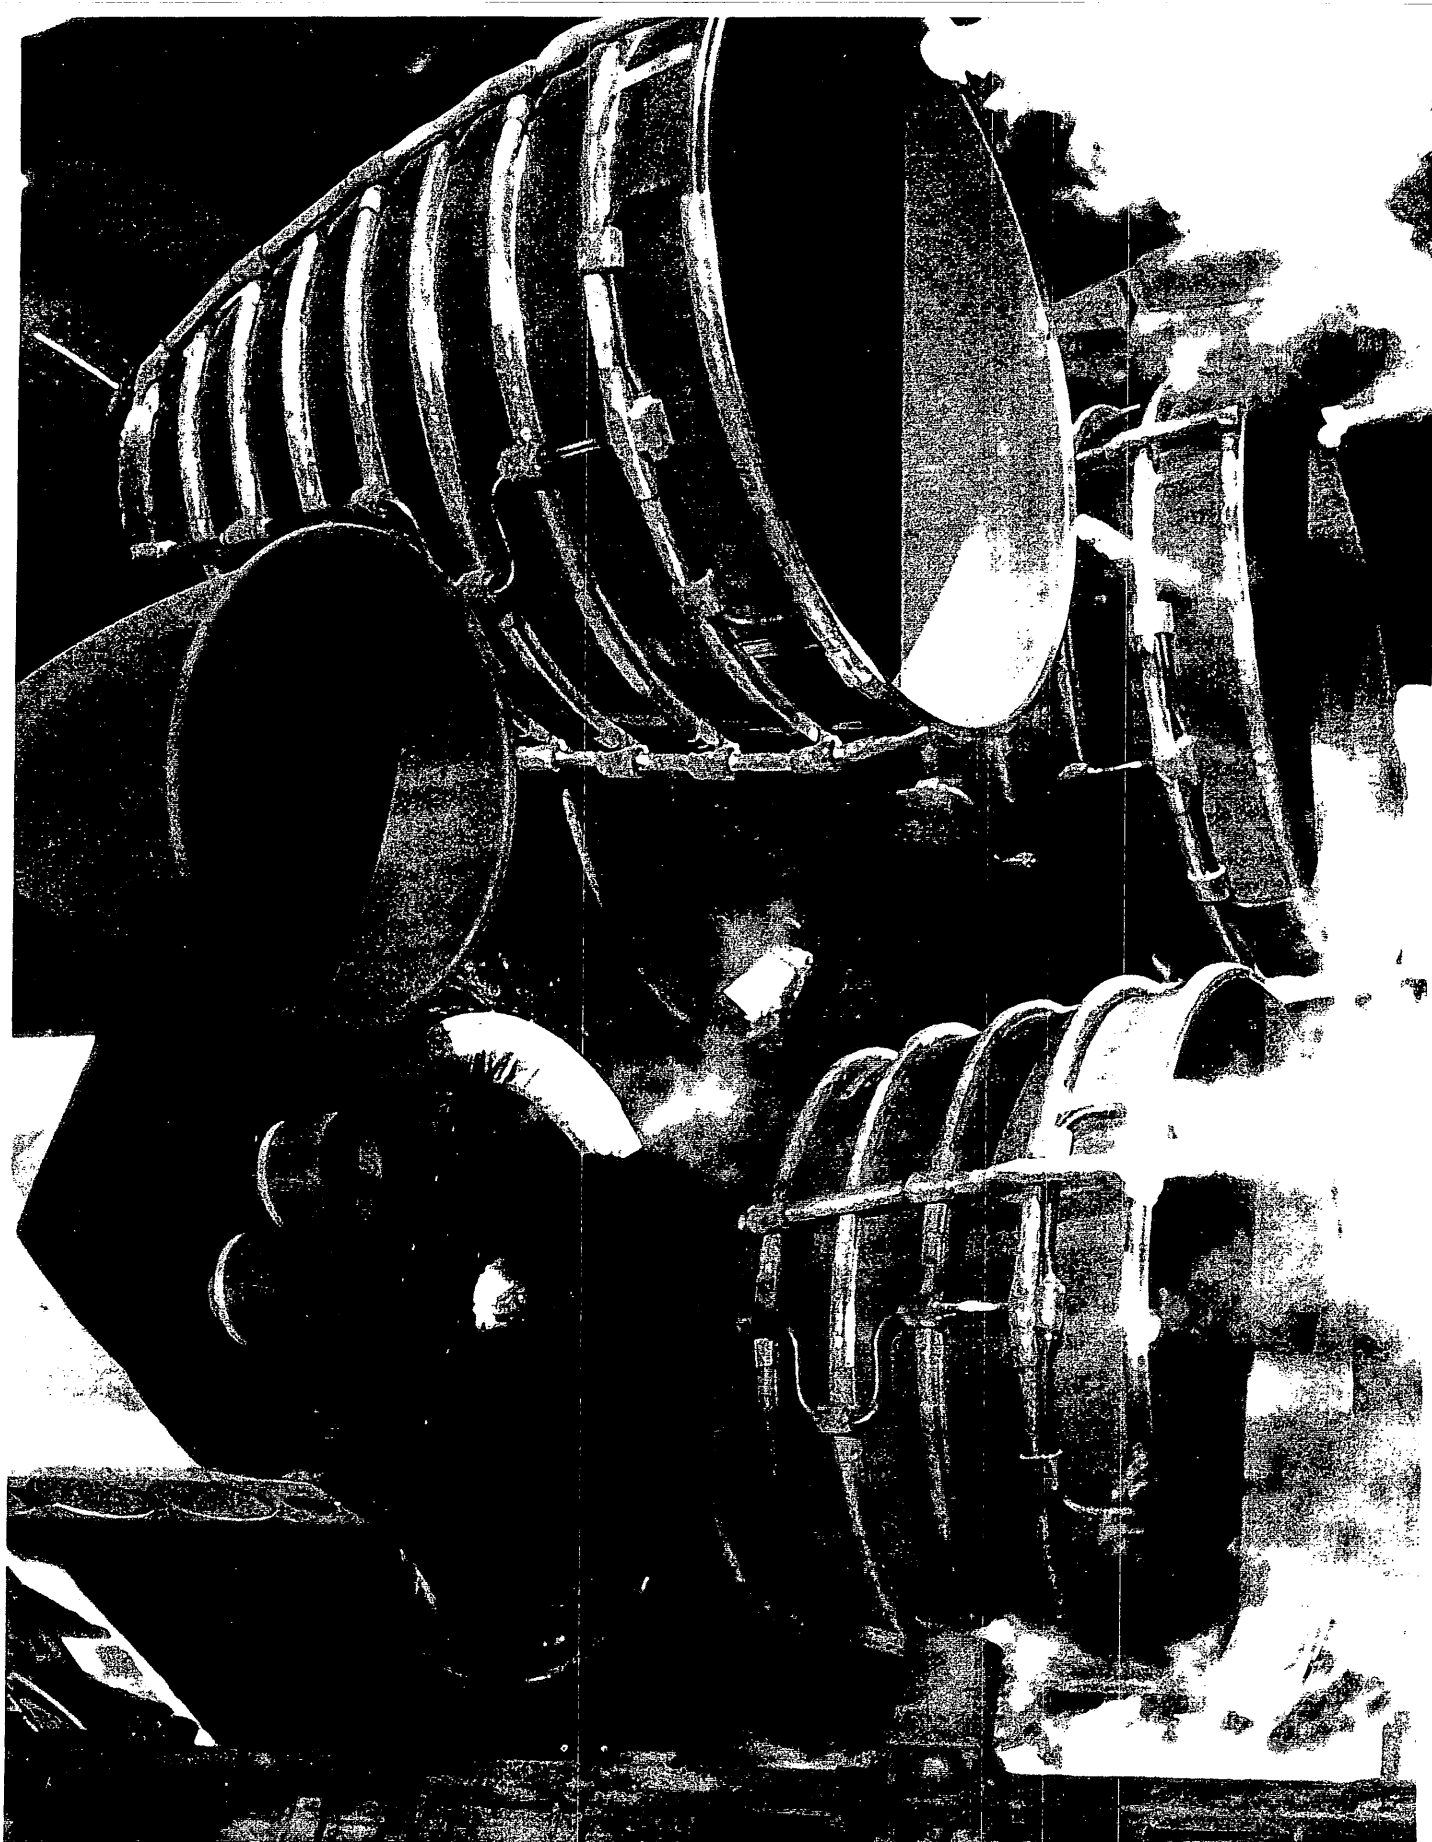
Overall view of SSME's. Note appearance of ice/frost at the
SSME #2 engine mounted heat shield interface.

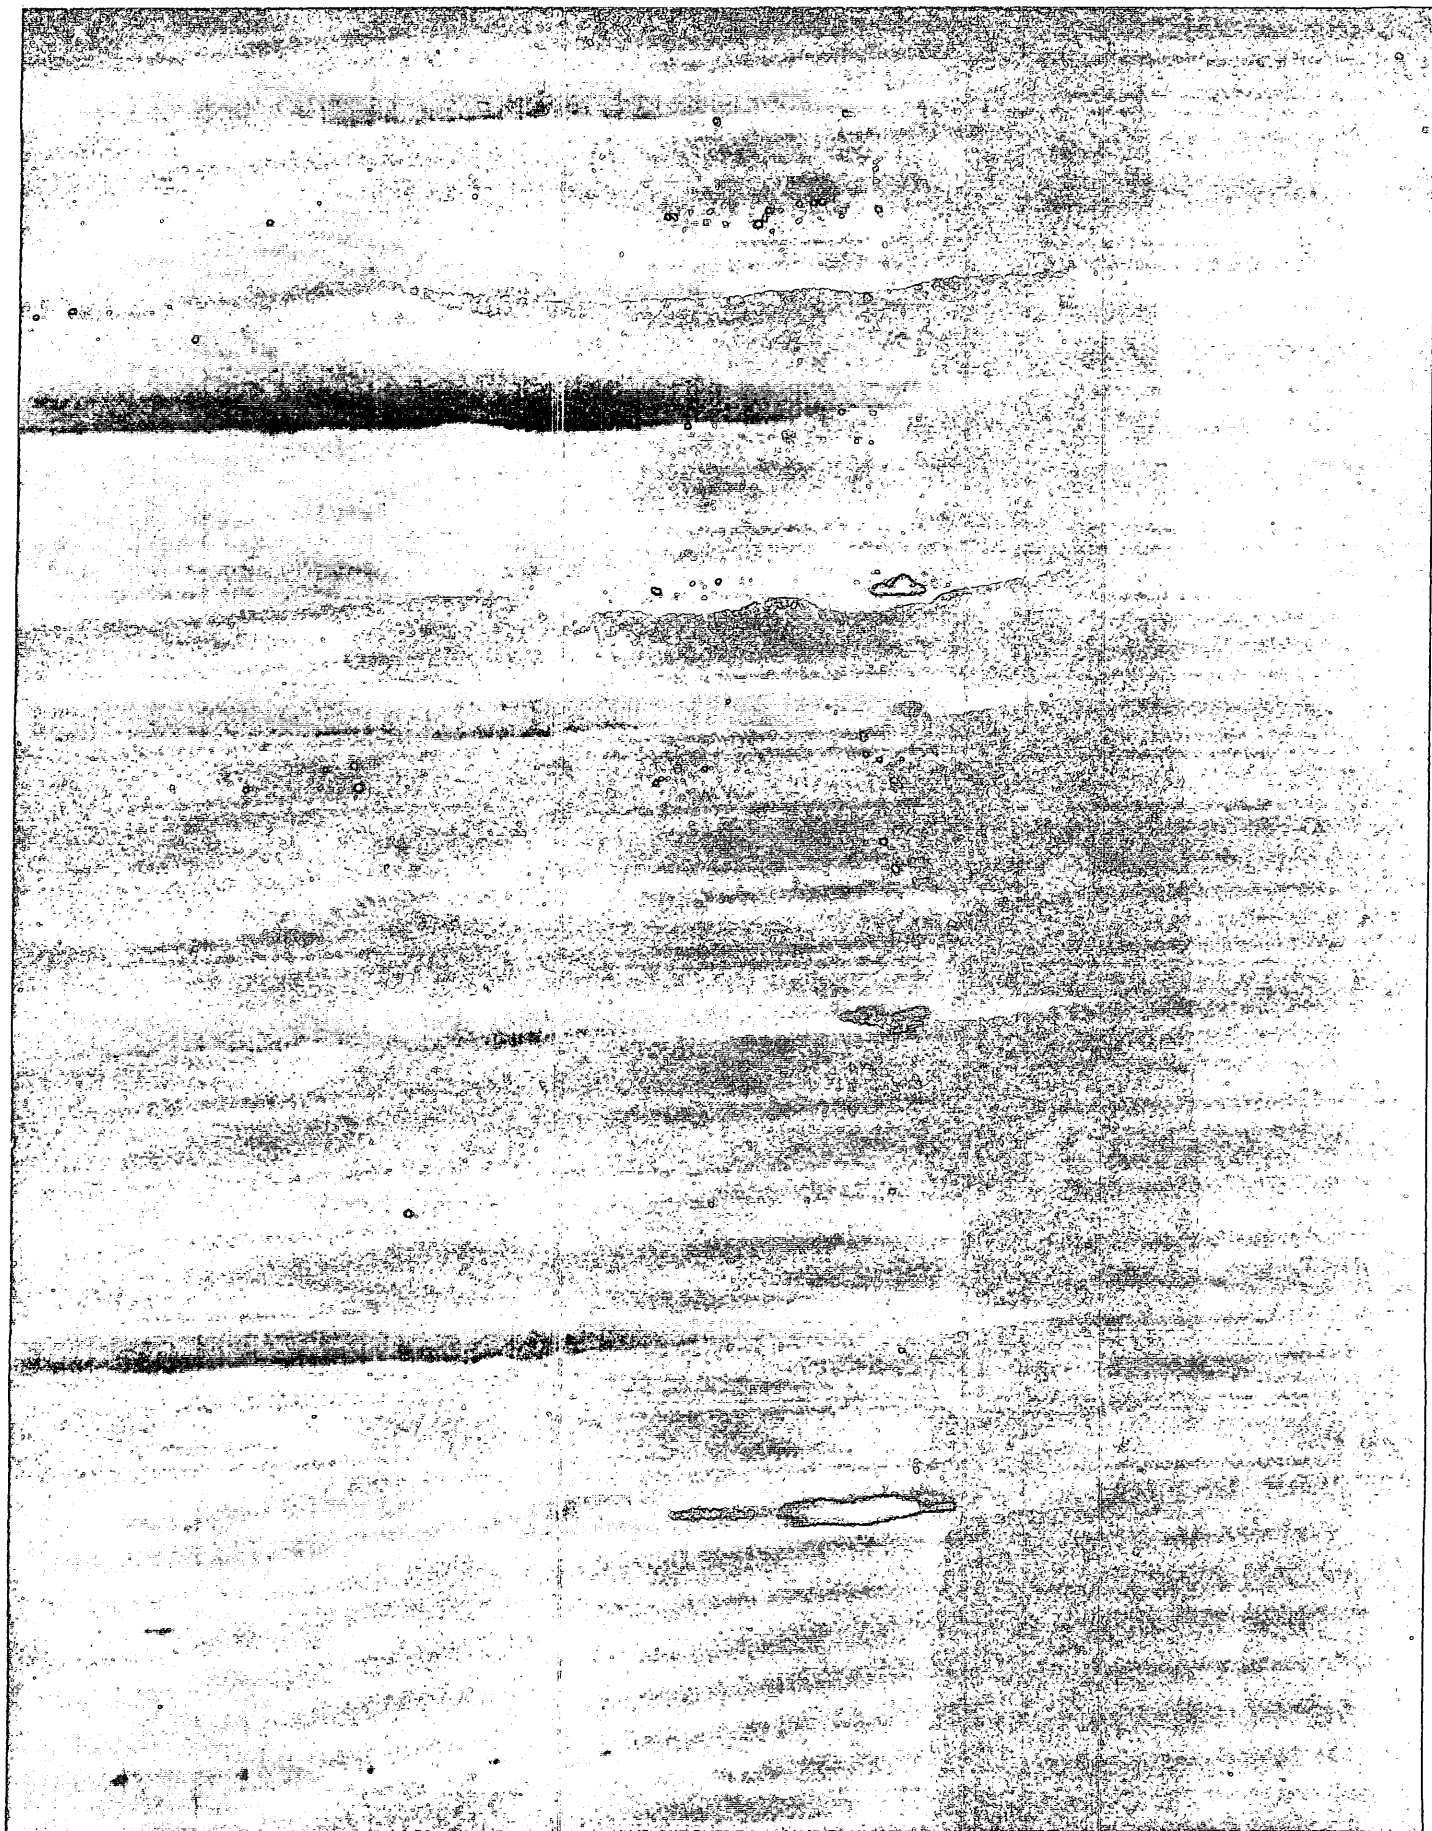
Frost accumulations in the intertank stringer valleys occurred
on the -Z side of the tank

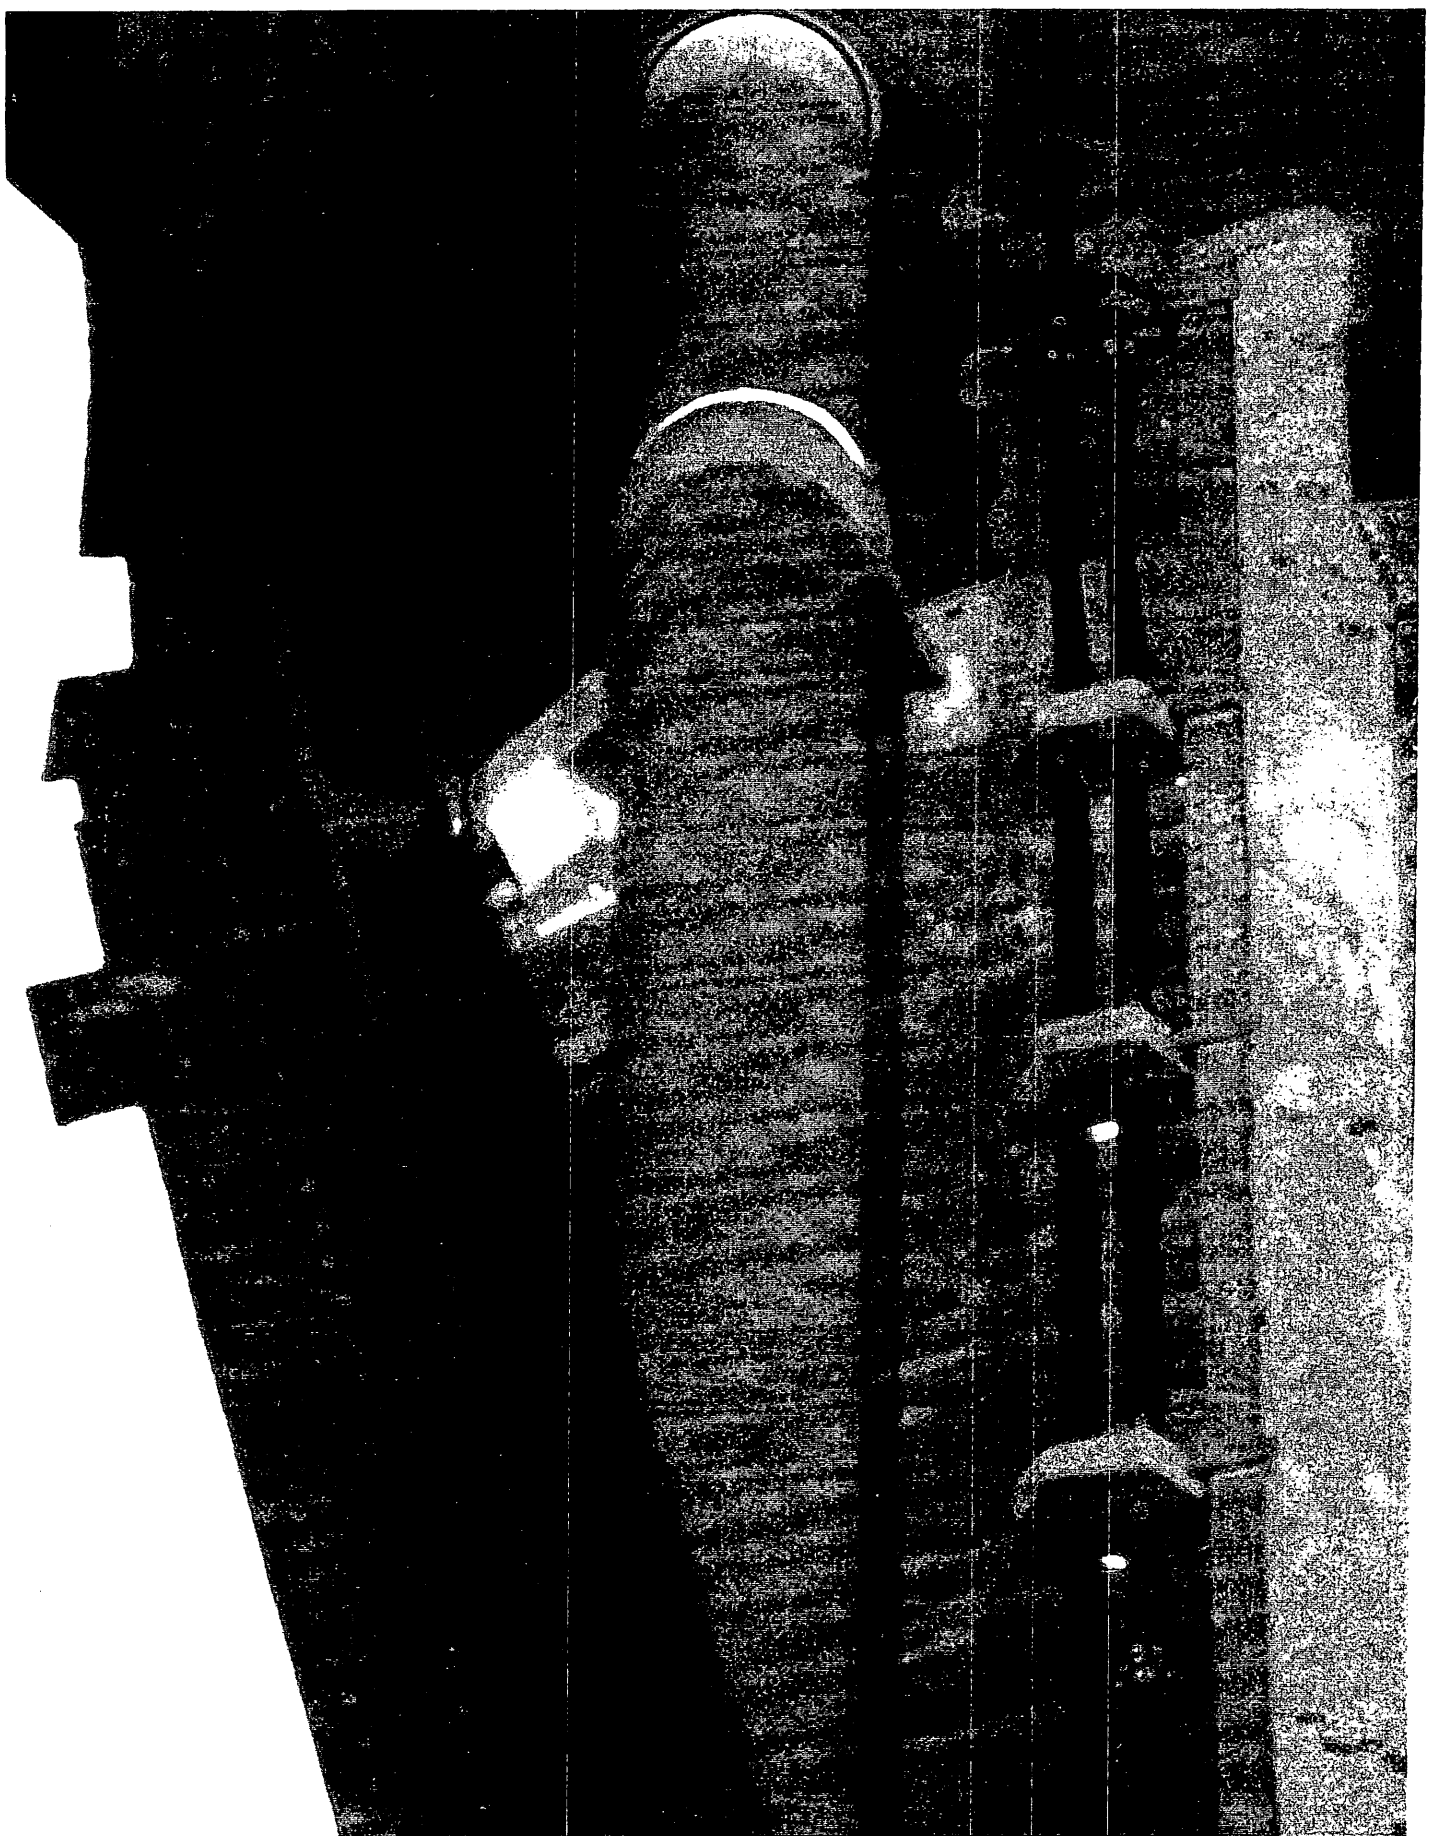
Typical amount of ice formed in the LO2 feedline upper bellows.
Ice/frost also formed along aft sides of the ice/frost ramps.

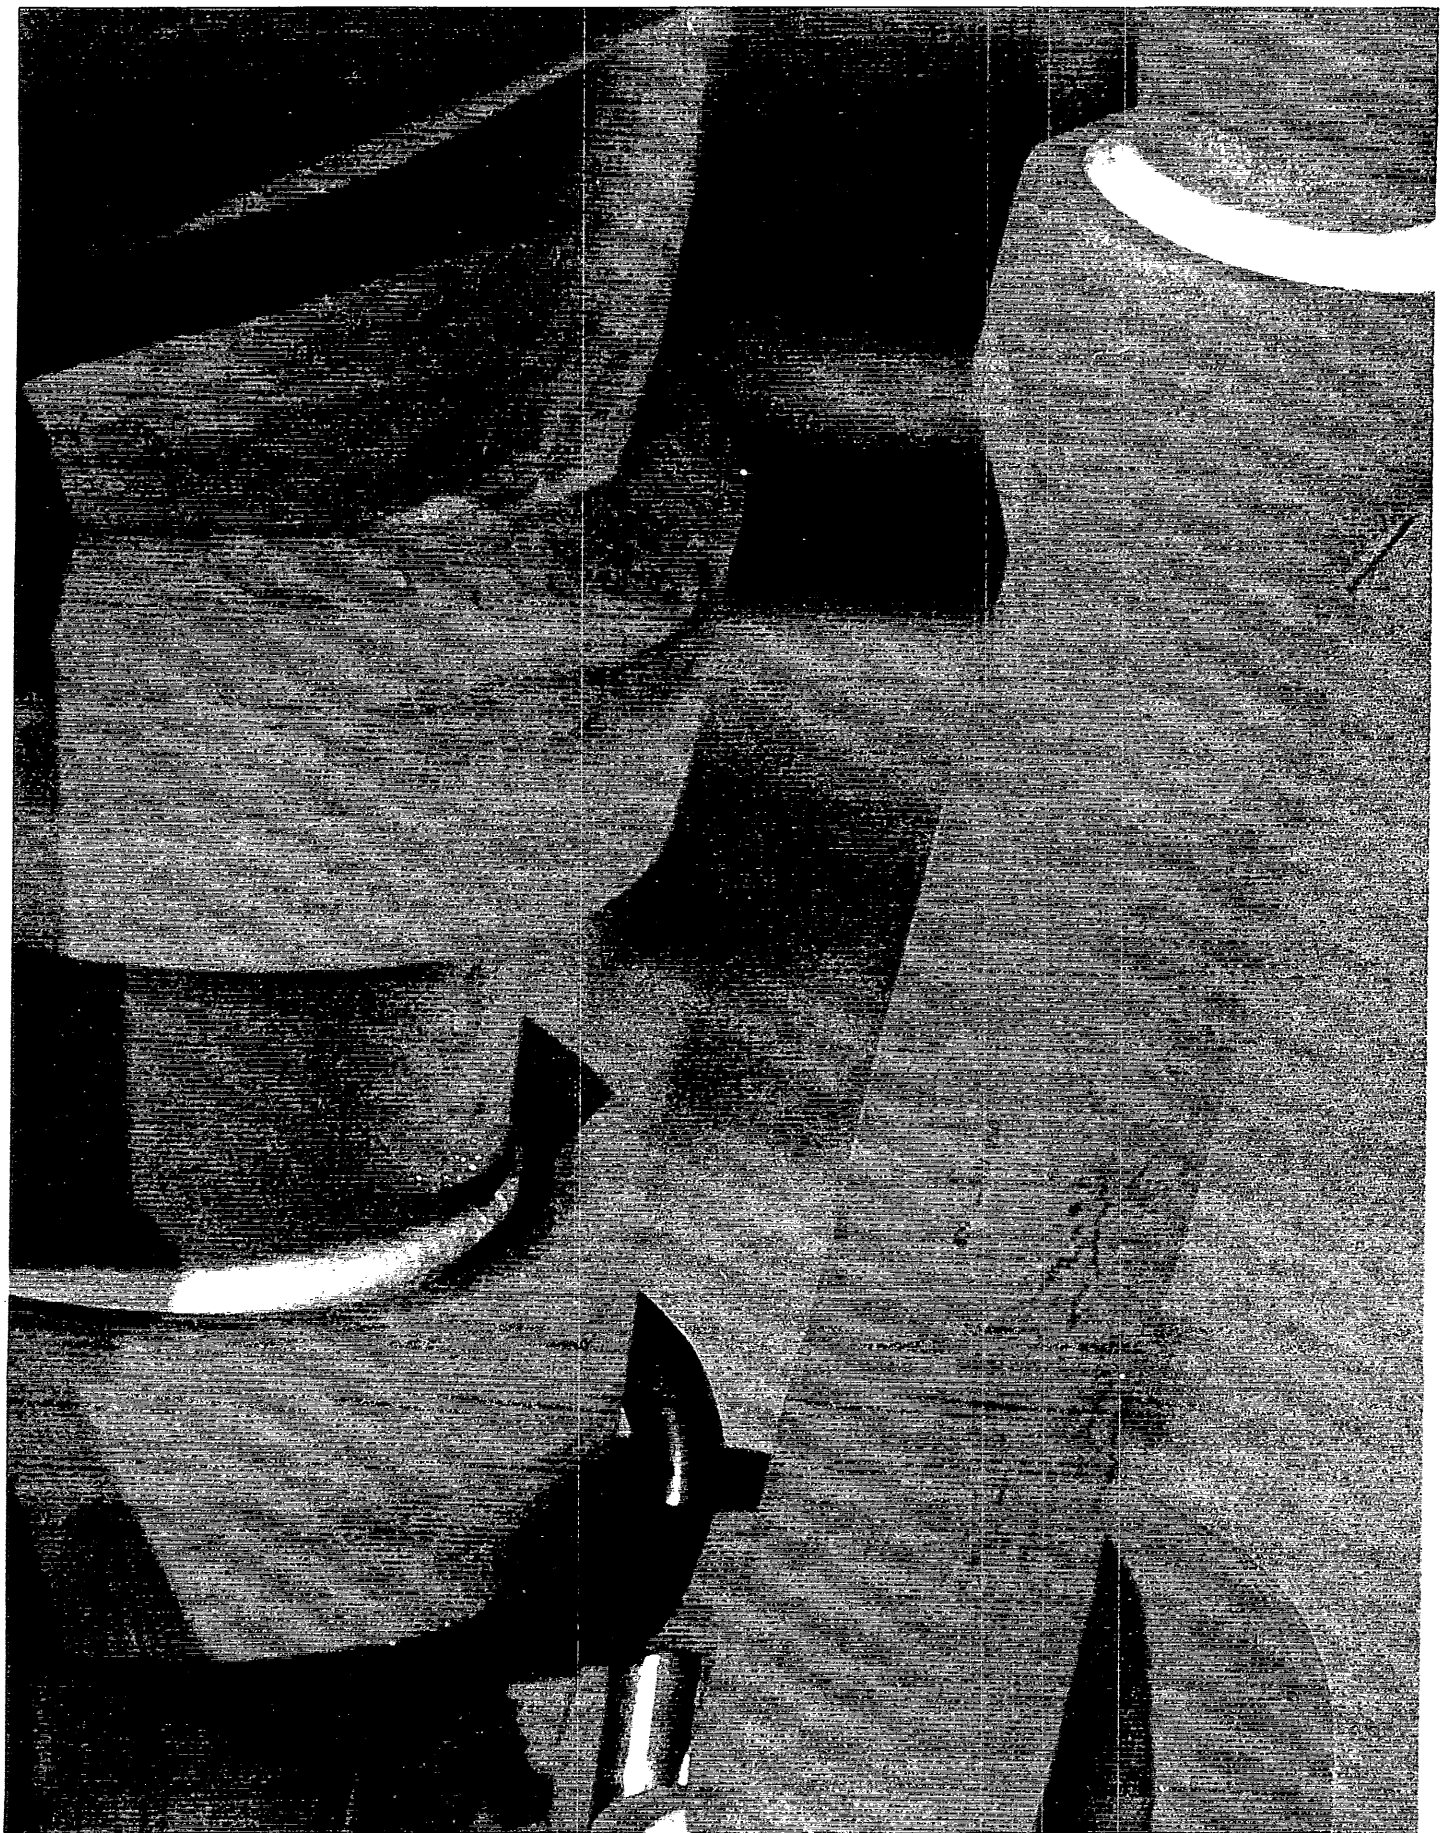
Ice/frost in the LH2 feedline and recirculation line bellows is normal. Two frost spots formed on the F/L flange closeout.

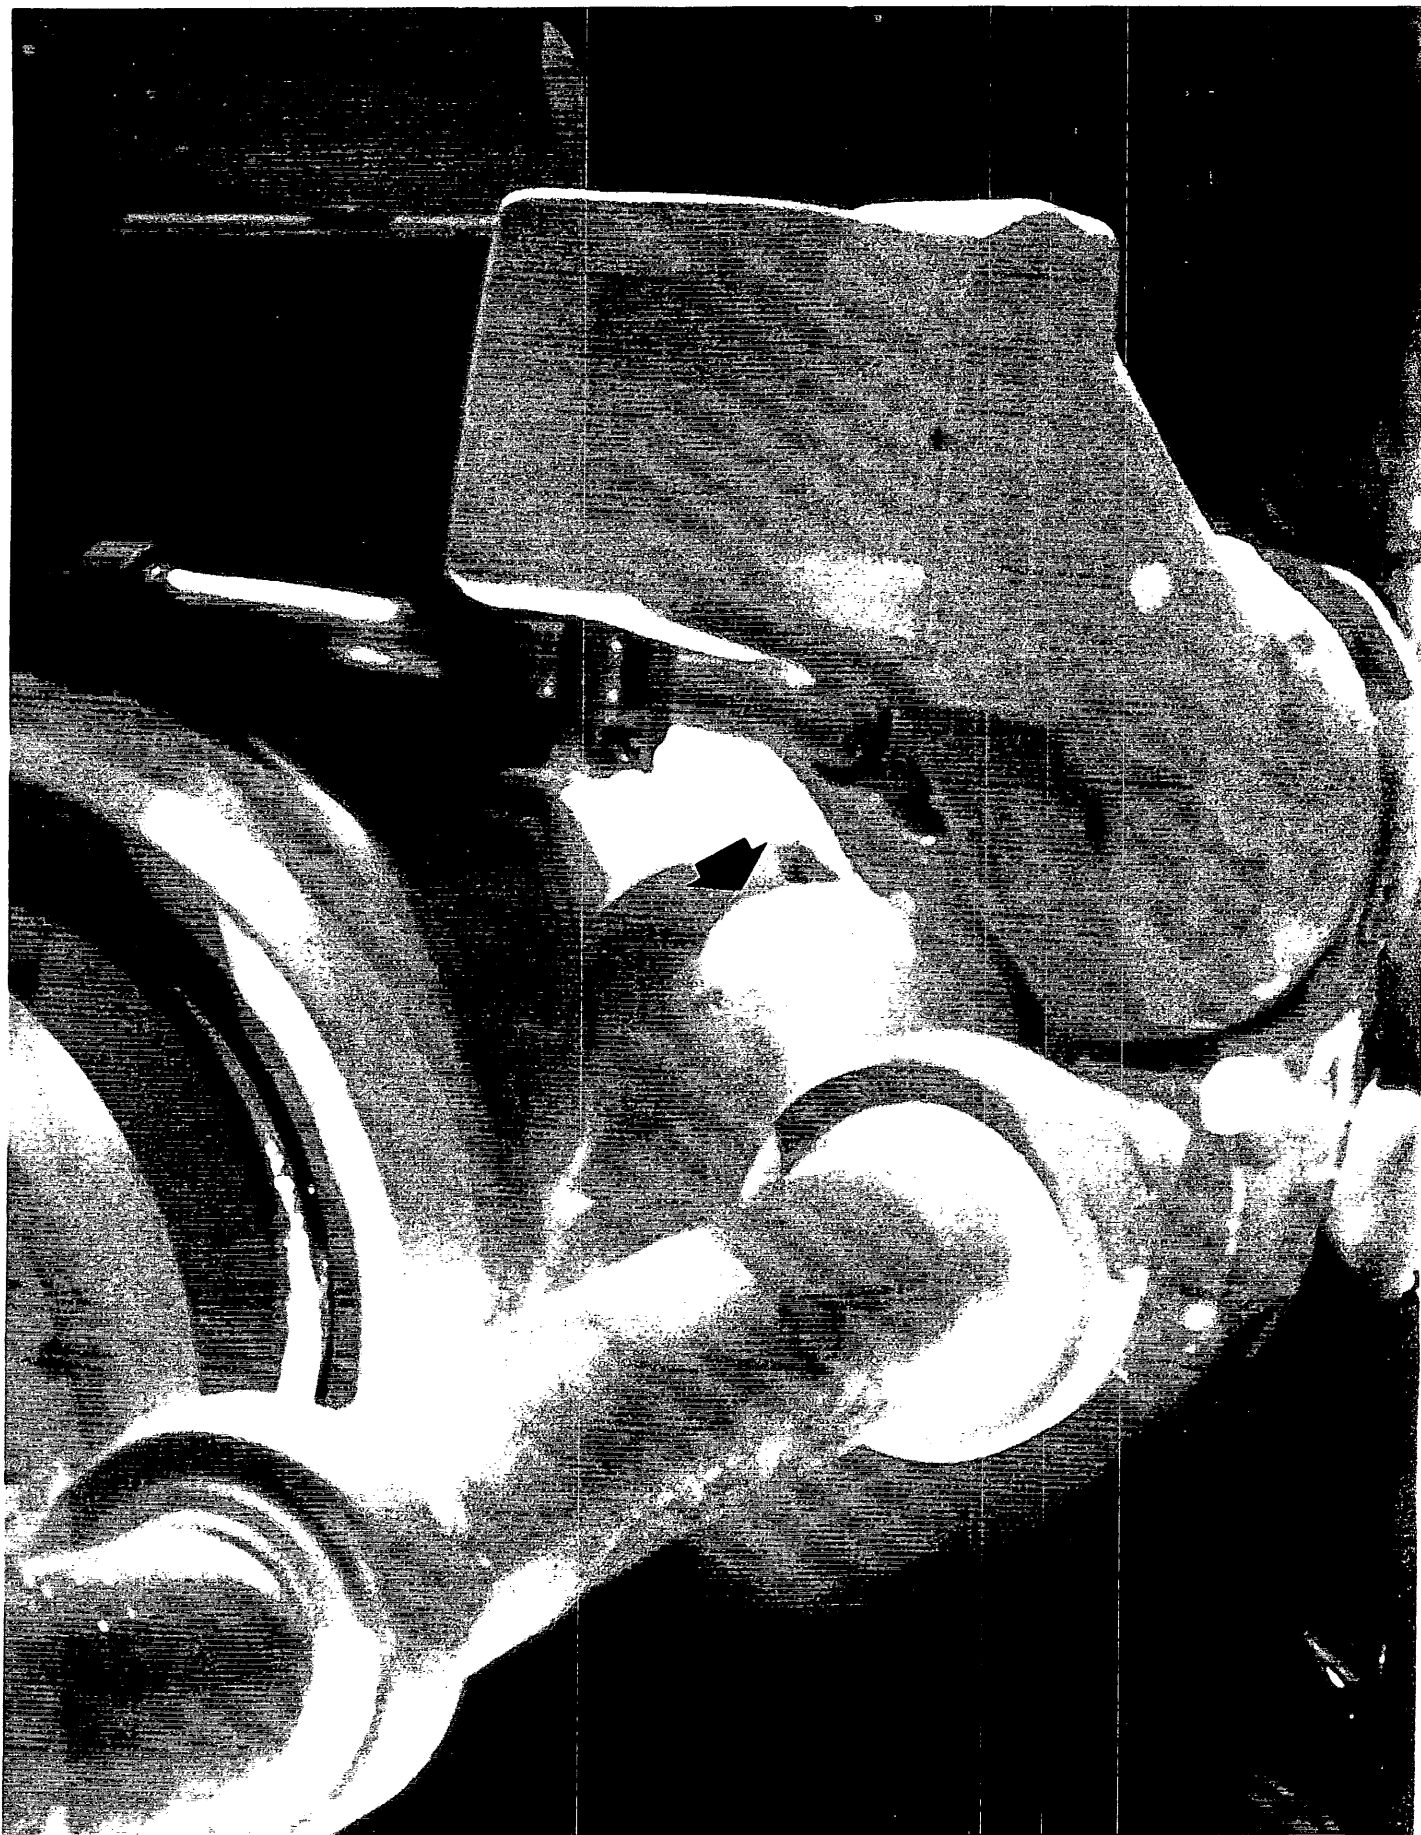
sealant on the upper outboard corner of this closeout allowed cold helium purge gas to escape. IPR 31RV-0180 was taken on this anomaly. The IPR was upgraded to PR ET-34-TS-0045 and dispositioned with MRB approval to use-as-is. Since this area was not one of the LCC or NSTS-08303 ice acceptance areas, LCC waiver LW021 was required (ref PRCB 570957L). Aside from this anomaly, the ET ice condition was well within the data base for ice formation at the time of launch.

An LCC waiver was granted for the 10"x10"x1" ice/frost covering the flapper valve actuator port PDL plug closeout

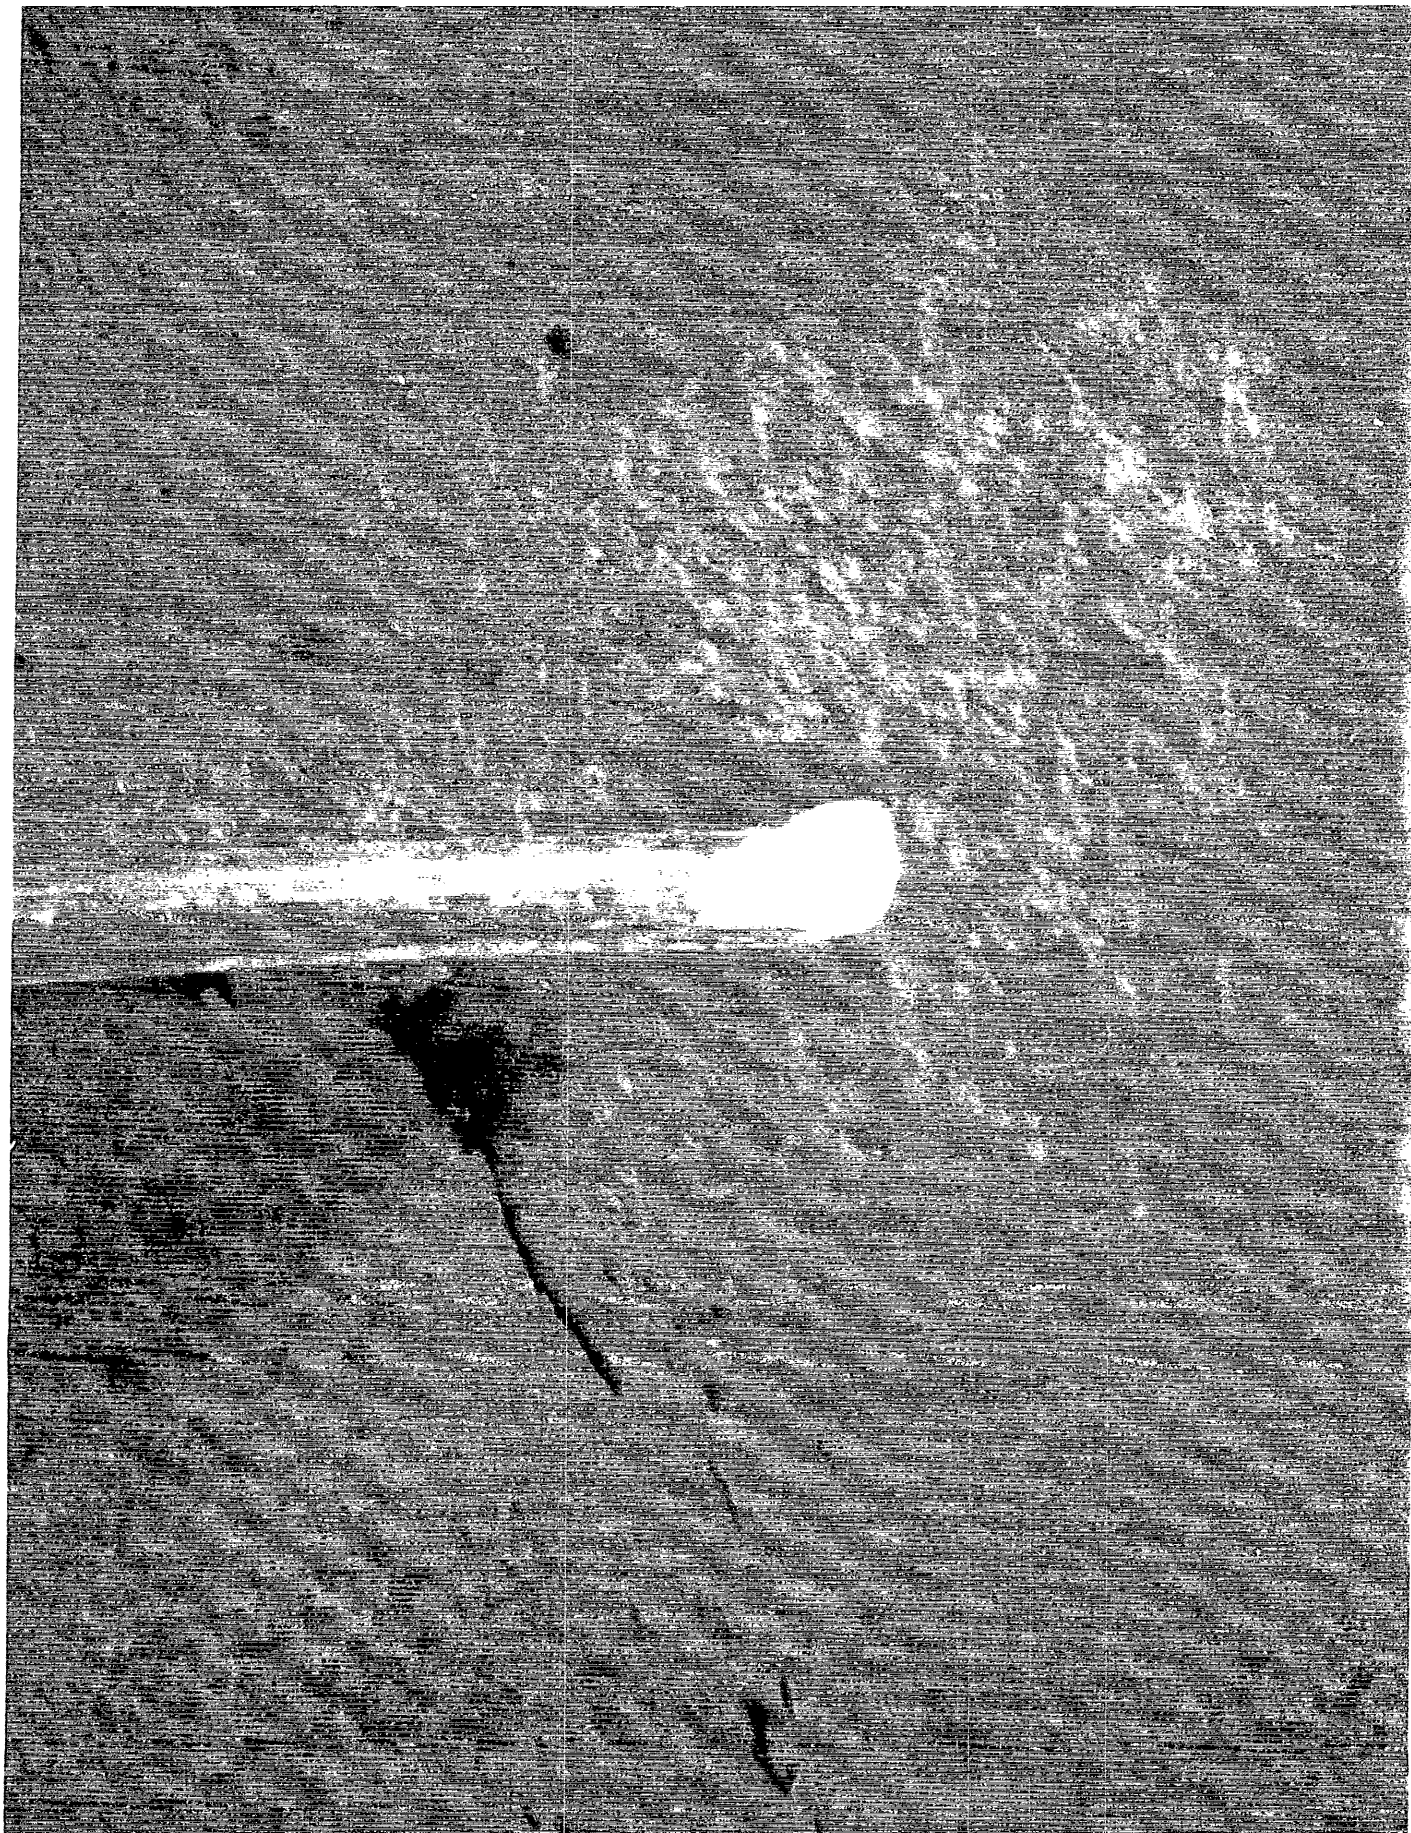
The ET/ORB hydrogen detection sensor tygon tubing was removed with no damage to the vehicle. However, the outboard tube had drooped close enough to the umbilical for ice to form around and in the end of the tube to a depth of 1-1/2 inches.

The hydrogen detection system tygon tubing drooped and became plugged when ice formed on top of the LH2 ET/ORB umbilical

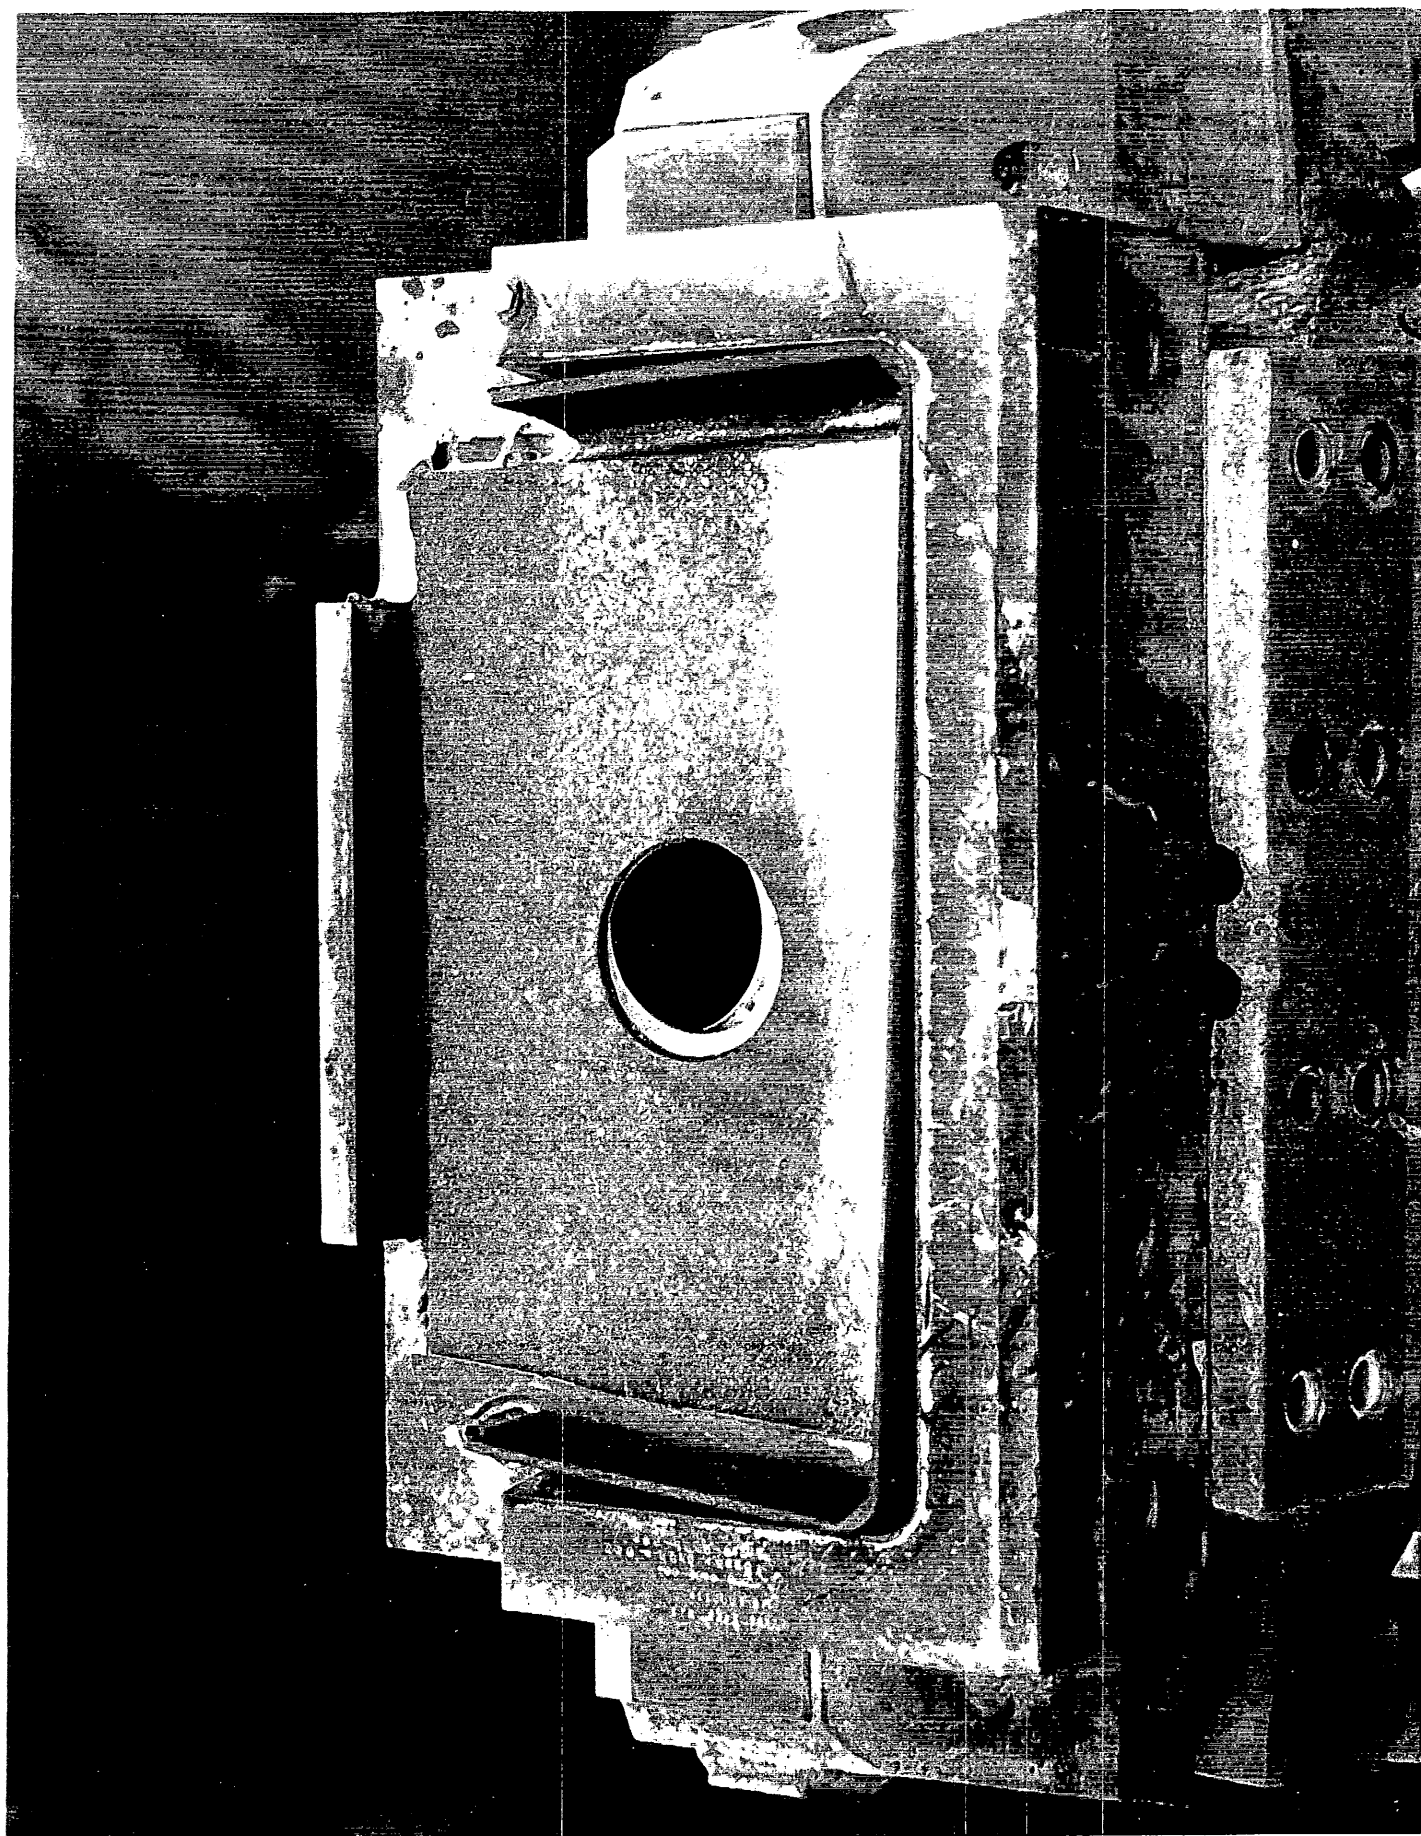
HDP #1 Epon shim material was 100 percent debonded

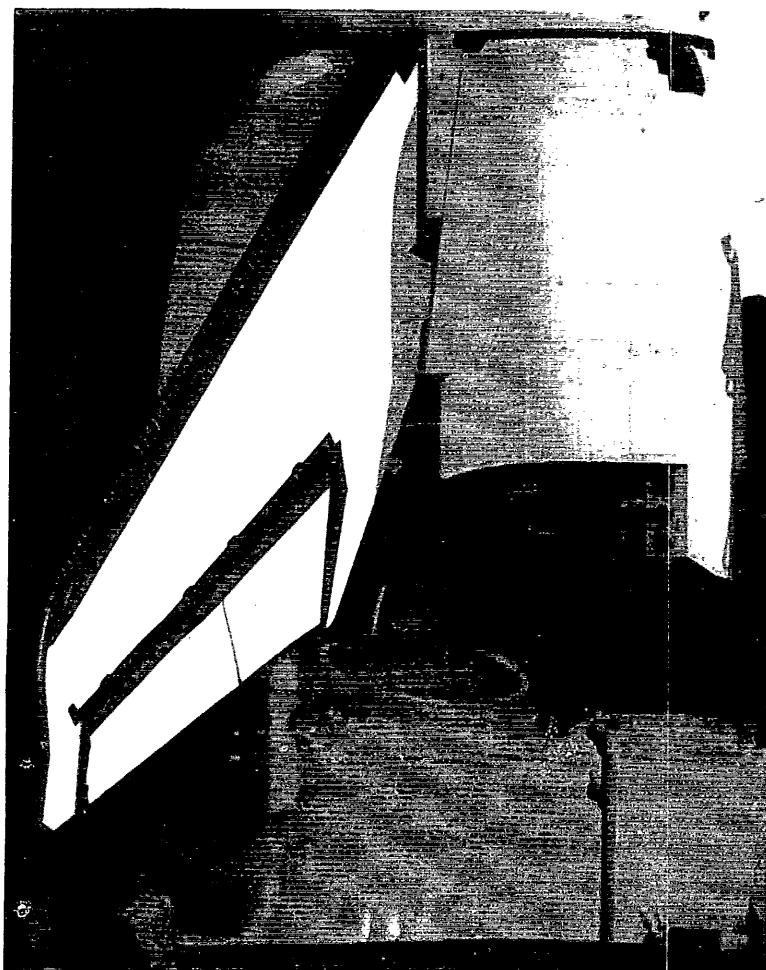
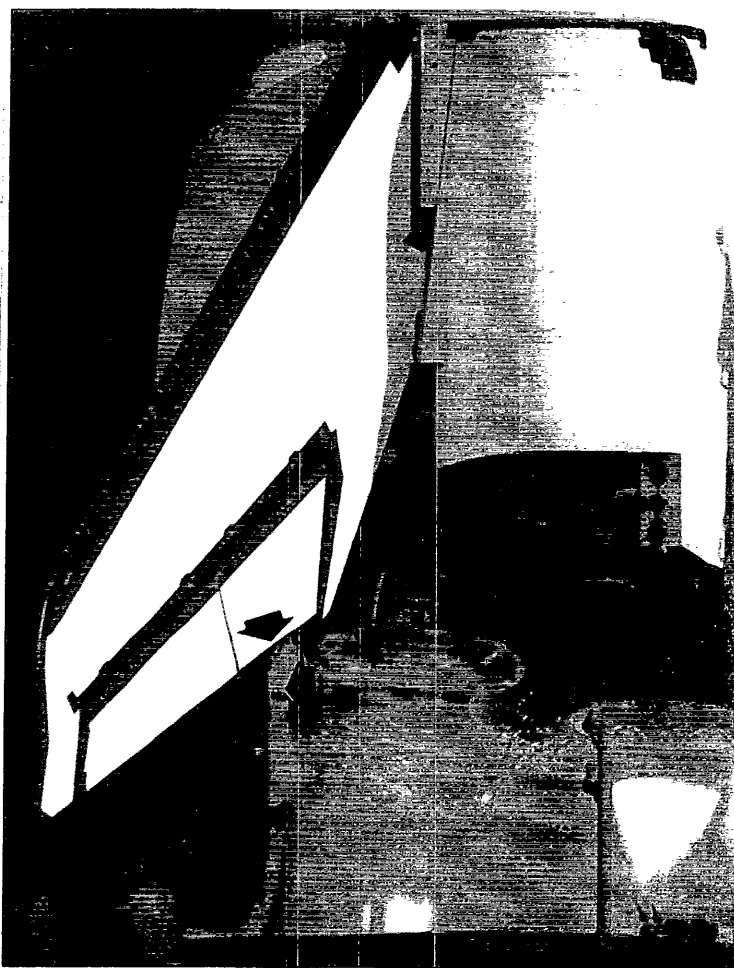
Before/after view of rudder speed brake as SSME ignition
acoustics/vibration cause a 2-1/2" chip in a tile (E-76)

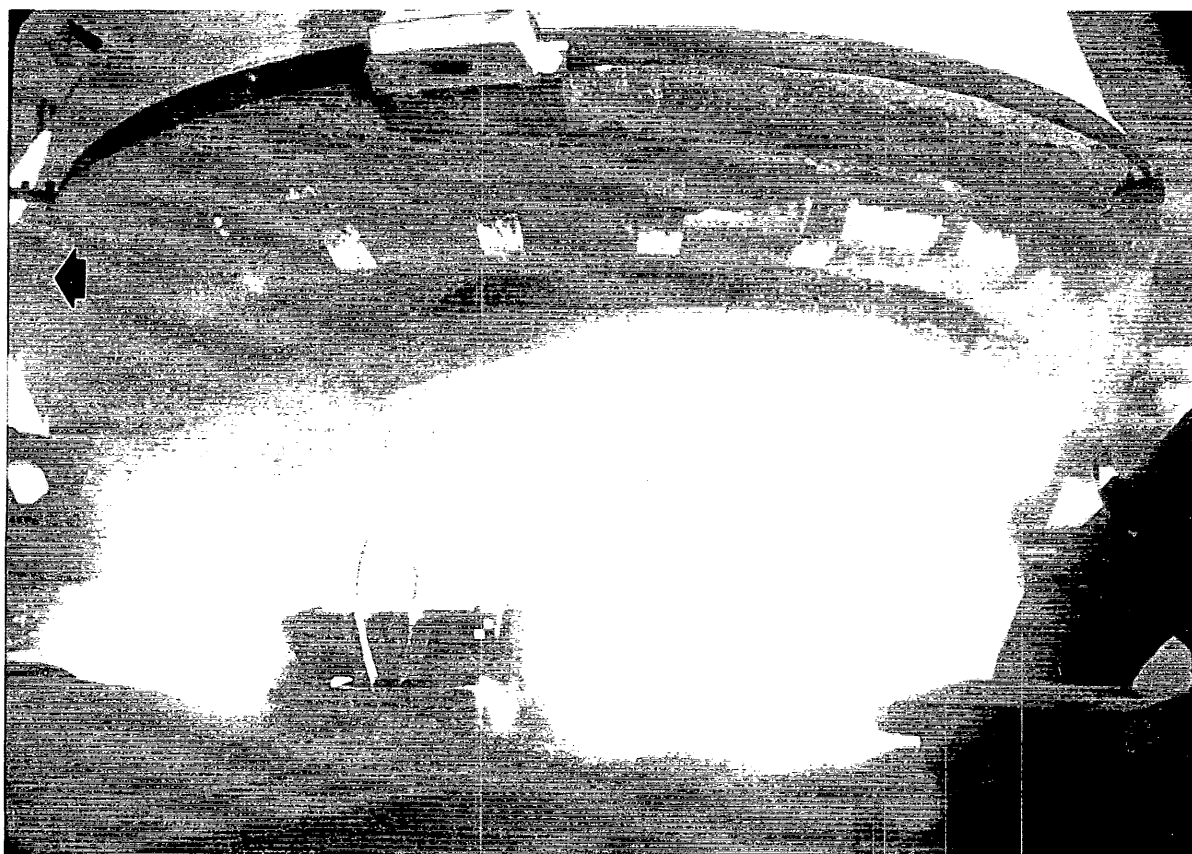
An ordnance debris fragment falls from the RH SRB HDP #1
stud hole shortly after liftoff (E-8)

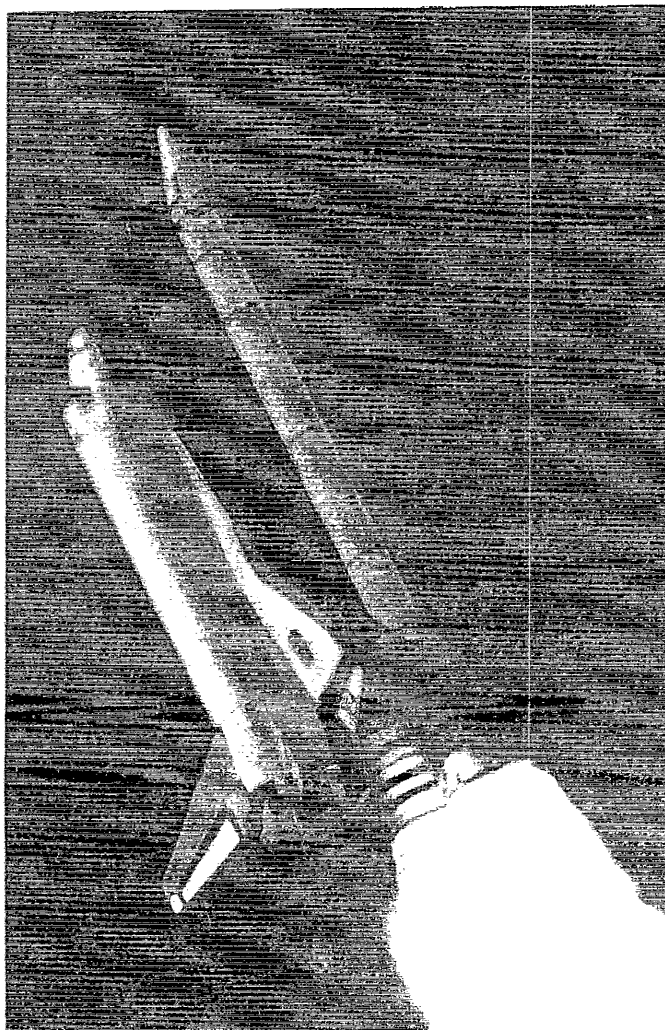
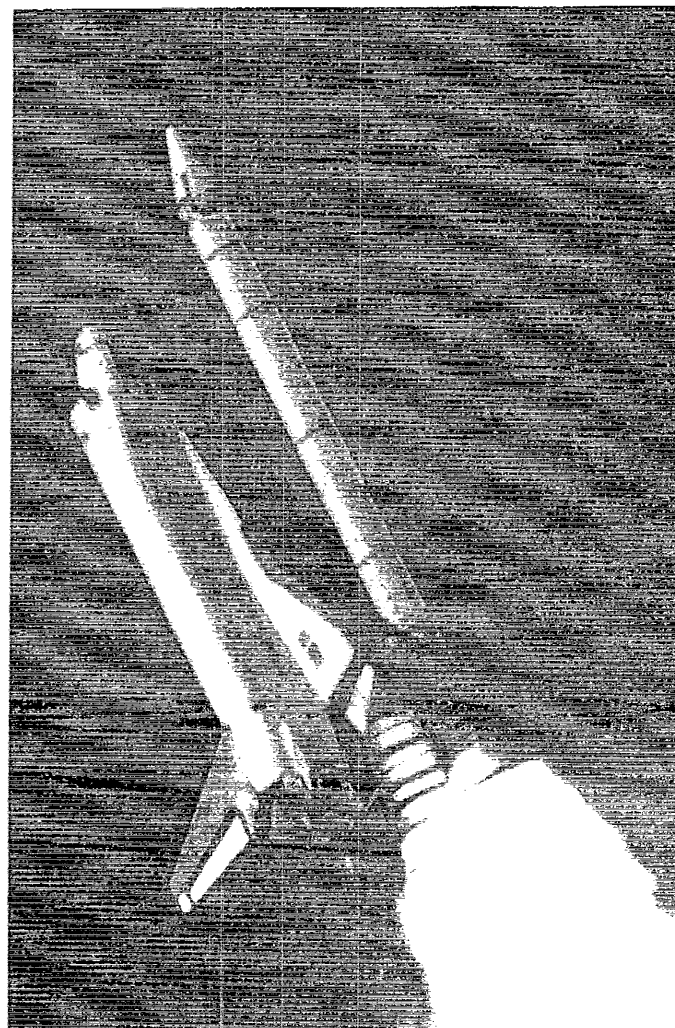
Orange flashes continue to occur in the SSME plumes during ascent (E-212) and may be caused by debris
